Singer 185 Case Repair

Among the machines that arrived in the shipment from my friend's warehouse was this pretty Singer 185 – the “updated” 1950s version of the famed 3/4-sized Singer 99. These are amazing little machines and are among my favourite mid-century Singers.

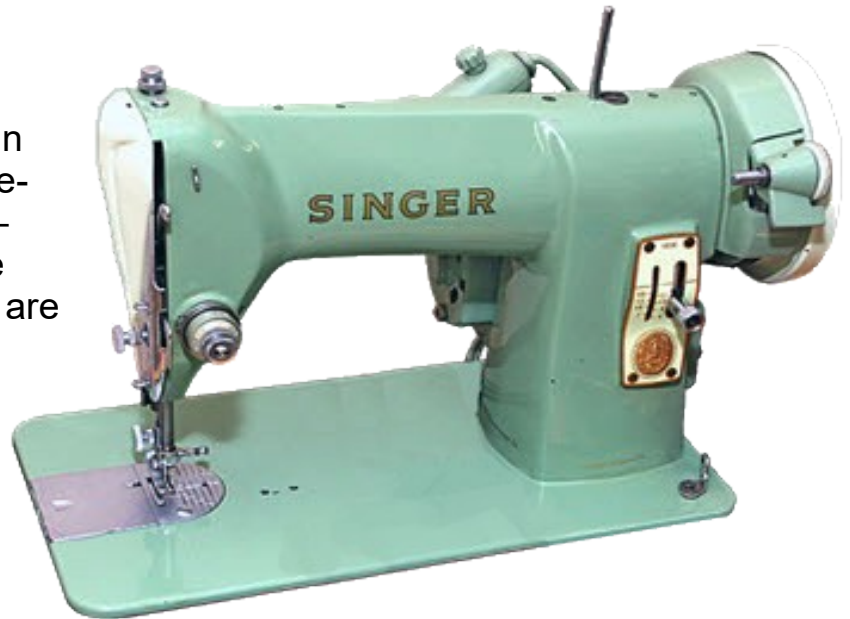
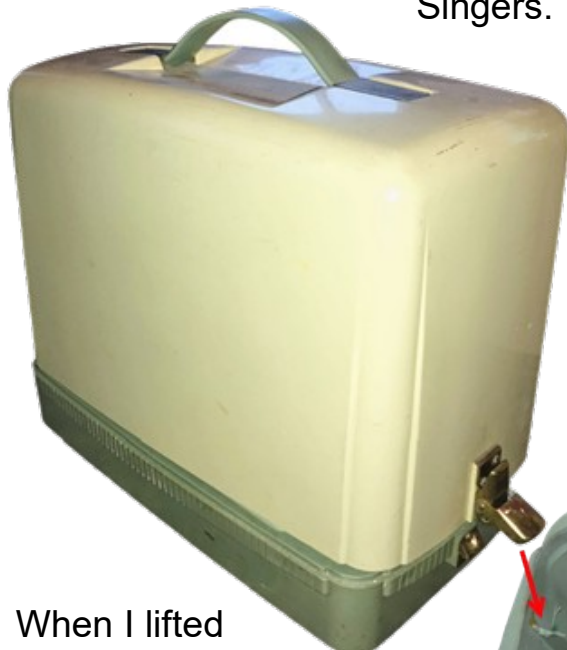
This one was housed in one of those two-tone plastic cases. These vintage cases are pretty, but after 70+ years, the hard plastic has become quite brittle and fragile, and less able to support the heavy machine head, as I learned when I opened the case on my machine.

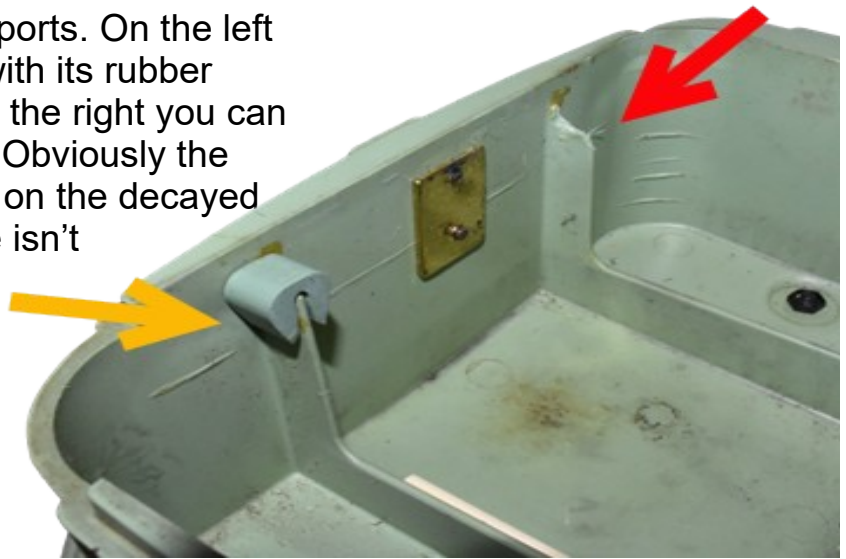
Here's a close-up of two of the supports. On the left is the one remaining intact flange with its rubber bumper in place (yellow arrow). On the right you can see a crumbled flange (red arrow). Obviously the bumper will no longer stay in place on the decayed flange, and as a result the machine isn't properly supported. No wonder it was leaning in the case.

To fix the issue, I'll need to either repair the existing flanges, or introduce some new supports. Shoring up the aging plastic flanges didn't really seem a

reasonable option, since plastic is notoriously difficult to repair successfully, and even if I could find a way to build up the plastic flanges, I didn't think they'd have the structural strength to hold the machine's weight. I decided to look for another way to support the machine inside the case.

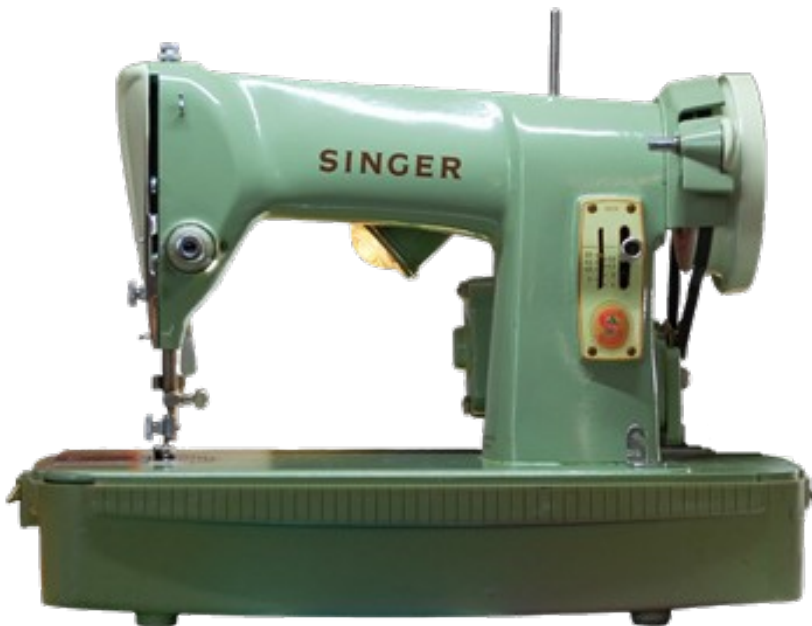
The Singer 185J now sits proud in its vintage base. At 3/4 size and in that beautiful seafoam green, it's as cute as can be.

Once the GOOP had set, I bolted the machine back into the case, and I can report that it's now sitting nicely level on its new supports, which (unlike the plastic) won't crumble with the years.
